RETSCHITZEGGER Stefan, BRUNNER Thomas, OBERNBERGER Ingwald, WALDMANN Barbara, 2012: Assessment of online corrosion measurements in combination with fuel analysis, flue gas, aerosol and deposit measurements in a biomass CHP plant. In: Proceedings of the International Conference "Impacts of Fuel Quality on Power Production and Environment", September 2012, Puchberg, Austria, ISBN 978-3-9502992-8-1

## ASSESSMENT OF ONLINE CORROSION MEASUREMENTS IN COMBINATION WITH FUEL ANALYSES, AEROSOL AND DEPOSIT MEASUREMENTS IN A BIOMASS CHP PLANT

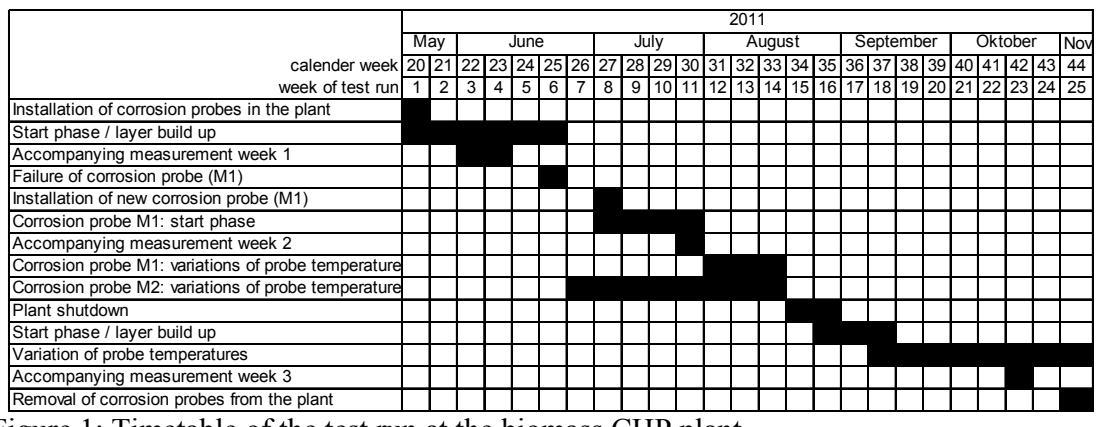
Figure 1: Timetable of the test run at the biomass CHP plant

The test run at the biomass CHP plant was started in the middle of May, 2011 and lasted 25 weeks until the beginning of November. Dedicated accompanying measurements were performed during three blocks, each consisting of one week. The timetable of the test run

is shown in Figure 1. After about one month, one corrosion probe had to be replaced due to a failure of the cooling unit. In August an unexpected plant shutdown took place which required about three weeks to gain a stable corrosion signal after the restart of the plant. The discontinuous measurements performed during the accompanying measurement weeks as well as the continuous measurements during the whole test run are explained in the chapters 3.1 to 3.5.

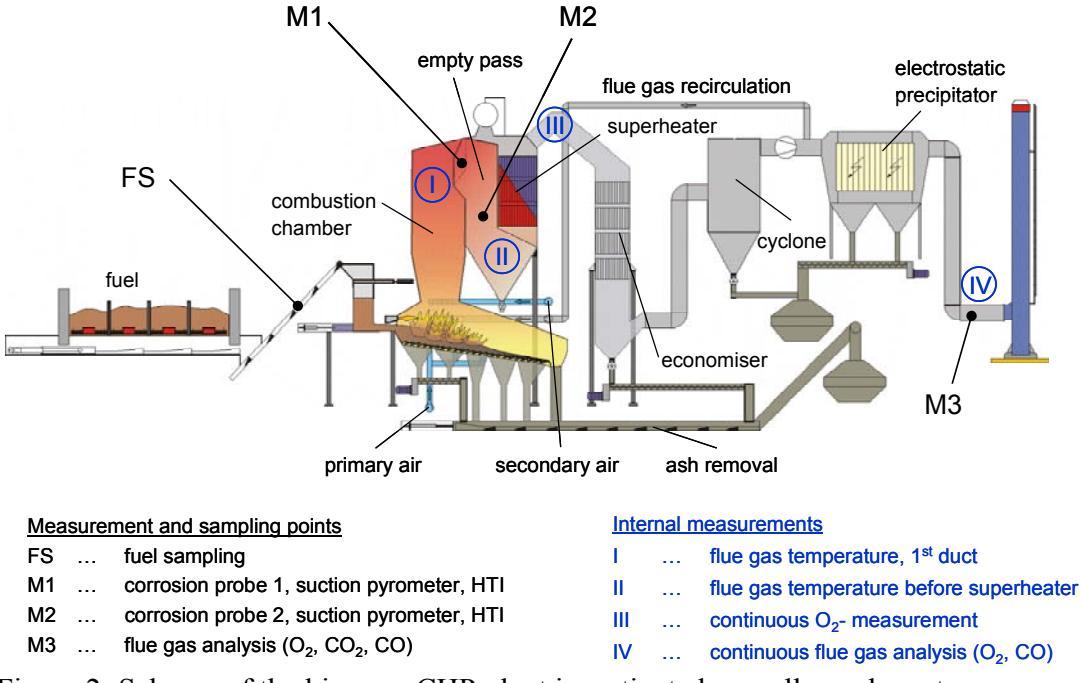
Figure 2: Scheme of the biomass CHP plant investigated as well as relevant measurement and sampling points

Explanations: HTI ... high temperature impactor

The biomass CHP plant is fired with chemically untreated woody biomass (wood chips). The plant consists of a grate-fired combustion unit with a 4-path boiler consisting of two radiative sections followed by a convective section which contains three superheater bundles and five economiser bundles (steam parameters: 32 t/h at  $480^{\circ}\text{C}$  and 63 bar). The nominal fuel power input is  $28 \text{ MW}_{\text{NCV}}$ , corresponding to an electric capacity of 5 MW and a thermal capacity of 18 MW (district heat supply). The plant is operated in heat controlled mode and covers the base load of the district heating network. A multi-cyclone and an electrostatic precipitator are applied for flue gas cleaning. Figure 2 shows the scheme of the plant, fuel sampling and corrosion measurement positions as well as relevant temperature and flue gas measurement points.

Two corrosion probes were inserted into the flue gas at the positions M1 and M2, shown in Figure 2 to investigate high temperature corrosion parallel at different flue gas temperatures.

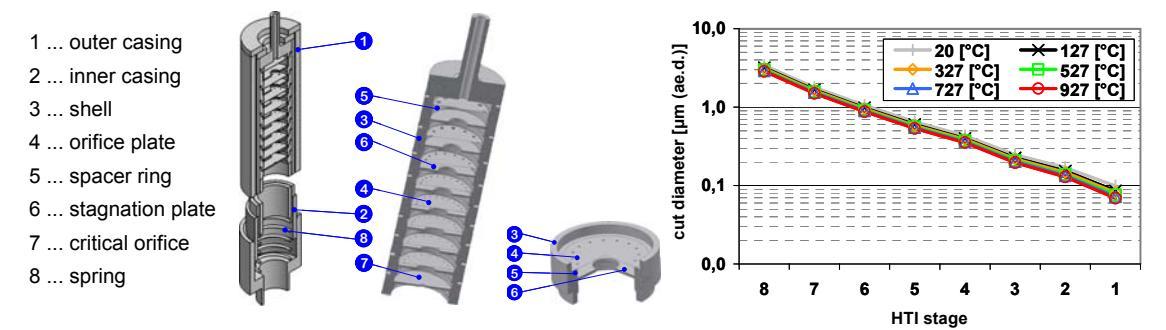
Figure 3: Scheme of the high-temperatur impactor (HTI) and cut diameters of the stages as a function of the flue gas temperature.

The concentrations and the particle size distributions of aerosols in the flue gas at the positions of the corrosion probes were determined with a high-temperature low-pressure impactor (HTI). The HTI (Figure 3) is an innovative development of the Graz University of Technology, Institute for Process and Particle Engineering [15] which enables in-site aerosol sampling at temperatures up to 1000°C. With the HTI particles are segregated in 8 size classes. The cut diameter of each stage is defined by the volumetric flow rate through the impactor, the number and diameter of identical orifices, the distance between the orifice plate and the stagnation plate and the flue gas temperature (see Figure 3). As sampling media Pt-foils are used to ensure thermal and chemical stability. Prior to the

sampling the HTI is positioned directly in the flue gas at the measurement position for 20 minutes for pre-heating. Pre-heating is needed to avoid cooling of the flue gas and particle formation by nucleation as well as ash vapour condensation in the HTI [11]. The sampling time (time during which flue gas is sucked through the HTI) itself is restricted to some minutes in order to avoid particle overloading. The Pt foils are weighed prior and after the sampling and based on the weight gain and the flue gas flow through the HTI during the sampling period the particle concentration for each stage is calculated (in mg/Nm<sup>3</sup>).

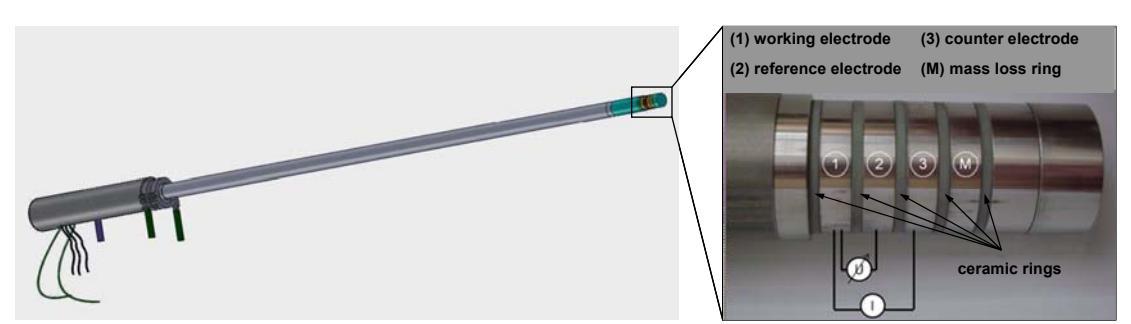
Figure 5: left: Corrosions probe; right: sensor with three electrodes (1 - 3) and the mass loss ring (M).

A temperature-controlled sensor (Figure 5 - right) is placed on the top of a water-cooled carrier-lance, which is about 200 cm long (Figure 5 - left). The corrosion probe is inserted into the flue gas of a combustion plant via an opening in the boiler casing. The sensor on top of the corrosion probe is cooled by air to a defined temperature. When exposed to the flue gas, a layer consisting of deposits and corrosion products is formed on the sensor surface. This layer represents an electrolyte and allows the measurement of the corrosion rate. The system is based on the measurement of a linear polarisation resistance.

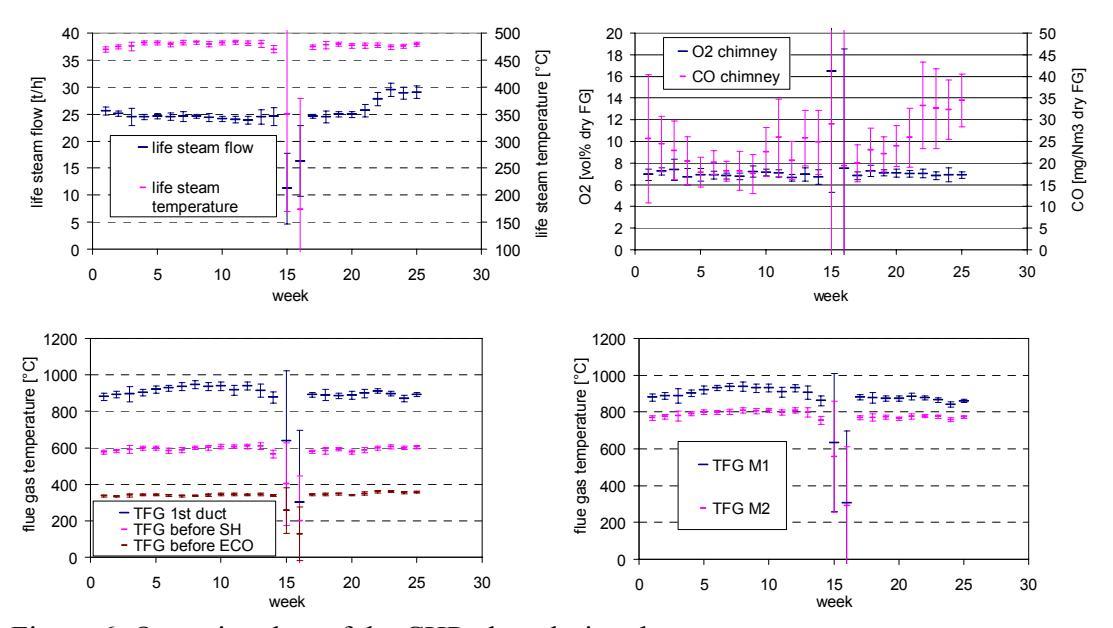
Figure 6: Operating data of the CHP plant during the test run <u>Explanations</u>: operating data were recorded in 1 minute intervals, shown are mean values of one week and the corresponding standard deviations; TFG ... temperature of the flue gas; SH ... superheater; ECO ... economiser; CO emissions related to dry flue gas and 13 vol% O<sub>2</sub>

Figure 6 shows weekly mean values as well as the standard deviations of relevant plant operating data. The plant was operated at rather stable conditions except for the weeks 15 and 16 where an unexpected plant shutdown took place. The shutdown happened in the middle of week 15 and lasted seven days which resulted in high standard deviations of the weekly mean values of measurement data, as shown in Figure 6. This shutdown affected the corrosion probe measurements to the effect that after the re-start of the plant the corrosion signals were rather unstable and it required about three weeks to regain a stable and meaningful corrosion signal. In the weeks 21 to 25 the boiler load was increased due to an increased demand from the district heating network, as it can be seen in the life steam flow. The life steam flows of 25.1 t/h (week 2) and 29.0 t/h (week 25) correspond to boiler outputs of 21.4 MW and 24.7 MW. The increased boiler load in weeks 21 to 25 resulted in increased flue gas flow rates but the mean values of the flue gas temperatures remained almost the same as at lower boiler load.

Consequently, for the whole corrosion measurement period stable and well comparable constraints regarding flue gas temperatures prevailed.

The continuous  $O_2$ -measurements show rather constant values, the variations of the COconcentrations can be caused by variations of the fuel moisture content, the fuel composition and the boiler output as well as by inhomogeneous distributions of the fuel on the grate. In general, a very good flue gas burnout is achieved.

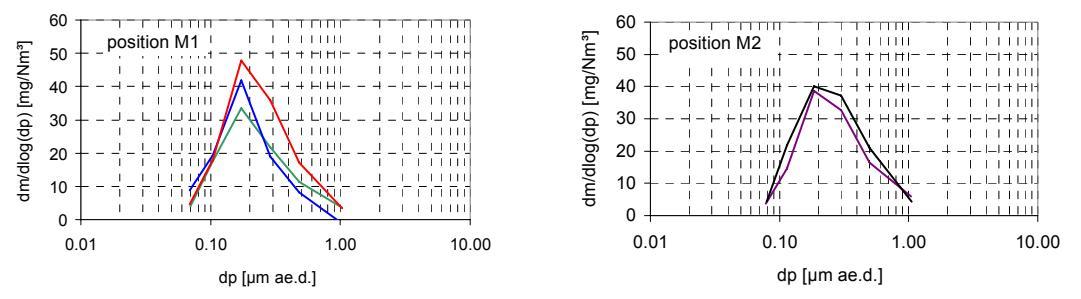
Figure 7: Particle size distributions of aerosols sampled at the positions of the corrosion probes

Explanations: all concentrations are related to dry flue gas and 13 vol.% O2; ae.d. ... aerodynamic diameter

High temperature aerosol measurements were performed at the positions of the corrosion probes. Figure 7 shows the particle size distributions of aerosols sampled with the high temperature impactor (HTI). The measurements were performed during the second accompanying measurement week (test run week 11), fuel compositions mentioned in this section are mean values of this week. At this time, the plant was operated at a mean life steam flow rate of 24.0 t/h (boiler output: 20.0 MW).

The particle size distributions show a typical maximum clearly below 1  $\mu$ m which tends to slightly increase from position M1 to M2 (aerodynamic diameters of the maxima are 0.17  $\mu$ m and 0.19  $\mu$ m). The particle growth takes place due to decreasing flue gas temperatures and therefore enforced surface condensation on aerosols as well as by agglomeration. The average aerosol concentration (sum of particles < 1  $\mu$ m sampled with the HTI) at position M1 amounts to 22.8 mg/Nm<sup>3</sup> respectively 24.4 mg/Nm<sup>3</sup> at position M2. These results are comparable to values found by Brunner [15] for wood fuels such as wood chips without bark (spruce) (aerosol concentration: 7.5 mg/Nm<sup>3</sup>) and bark (aerosol concentration: 32.0 mg/Nm<sup>3</sup>), sampled in a pilot-scale grate combustion plant in the secondary combustion zone.

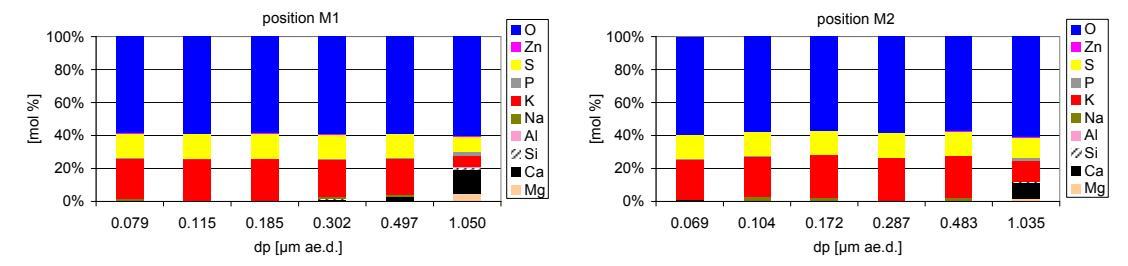
Explanations: dp ... geometric mean diameter of the respective impactor stage (aerodynamic diameter); O has been stoichiometrically calculated

SEM/EDX analyses of the aerosols were performed for one HTI measurement from each position. The results of the analyses are shown in Figure 8. At both positions, all size classes  $< 1 \mu m$  show K and S as main elements. Their ratio indicates K<sub>2</sub>SO<sub>4</sub> to be the main component. In addition, Na is found in minor amounts, most probably in the form of Na<sub>2</sub>SO<sub>4</sub>. Particles  $> 1 \mu m$  contain besides K<sub>2</sub>SO<sub>4</sub> also Ca and Mg compounds, most likely sulphates and oxides. These are typical results for the combustion of chemically untreated wood fuels.

No Cl was found in the aerosols analysed. This is an expected result since it is known that Cl forms alkali chlorides and HCl which are expected to be in gaseous form at the flue gas temperatures at the measurement positions (Figure 8) [15].

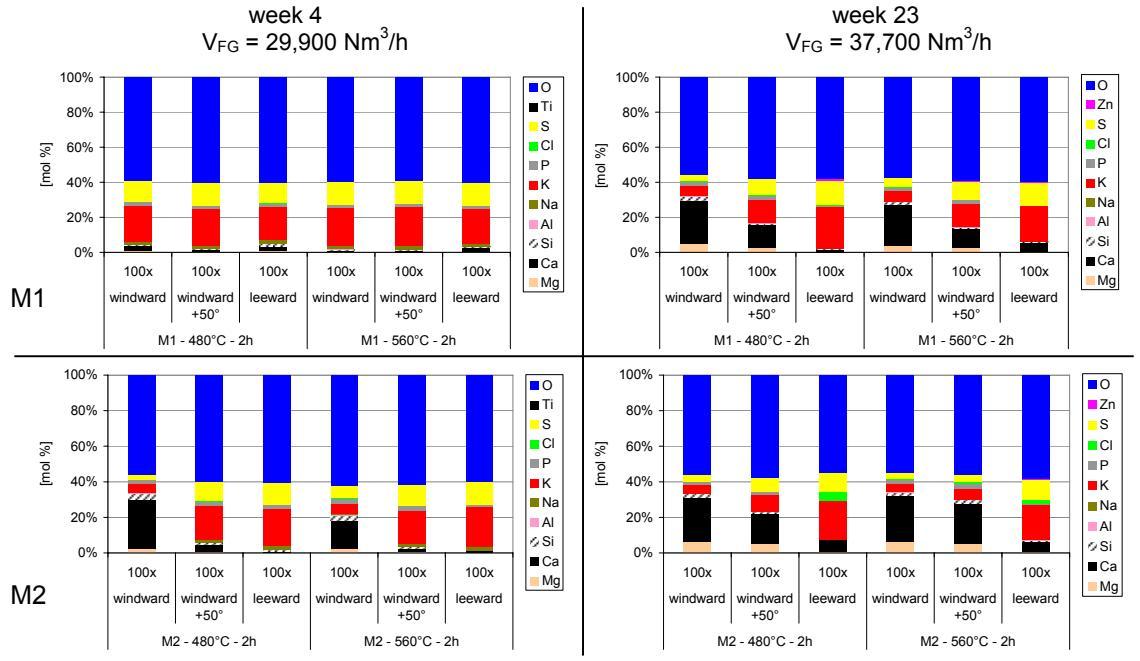
Figure 9: Results of SEM/EDX analyses of the deposits sampled at the positions of the corrosion probes

<u>Explanations</u>: the caption of each analysis characterises the sampling point, the surface temperature of the test ring and the sampling time - e.g.  $M1 - 480^{\circ}C - 2h$

The analyses of the deposits sampled (Figure 9) generally show, that the variation of the surface temperatures of the test rings did not significantly influence the chemical composition of the deposits. Analyses of deposits at position M1 show that at lower boiler load the deposits mainly consist of  $K_2SO_4$  independently of the point analysed. With increased boiler load, higher concentrations of Ca and Mg are found in the deposits, especially at the windward side. A similar trend is seen for the deposit composition at position M2, although not as distinctive as at position M1, since at position M2 Ca is also found in higher quantities at the windward side at lower boiler load due to different flow conditions. Measurement position M2 is located in the main flue gas flow whereas Position M1 is located outside of the main flow. This evaluation is based on the CFD-simulation, see section 3.5. The increase of Ca and Mg in the deposits in week 23 can be explained by the higher entrainment of particles from the grate since these elements are typical constituents of coarse fly ashes.

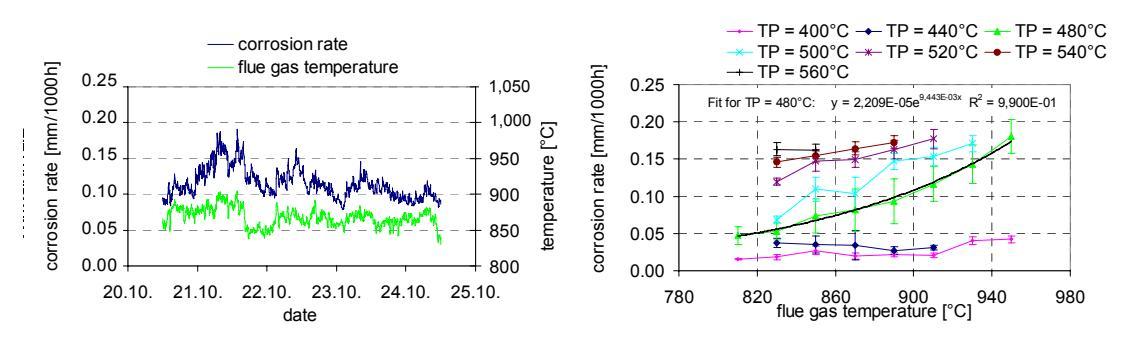
Figure 10: Corrosion rates of the corrosion probe at position M1 in dependence on the flue gas temperature at constant surface temperatures of the corrosion probe <u>Explanations:</u> TP ... temperature of the corrosion probe; right figure: mean values at certain flue gas temperatures (+/- 10°C) and certain corrosion probe temperatures (+/- 1°C); exponential fit of data for TP = 480°C; error bars show the standard deviations

Figure 10 - left shows the corrosion rates at a constant probe temperature of 480°C. Figure 10 - right shows mean values of corrosion rates for certain flue gas temperatures

and probe temperatures. The data in Figure 10 - right were gained over the whole corrosion test run. A clear trend of increasing corrosion rates with increasing flue gas temperatures can be seen. It has to be noted, that a mathematical description of the corrosion rates has not been developed yet and the exponential fit for the probe temperature of 480°C serves just for the purpose of investigating a possible influence of the flue gas velocity on the corrosion rate, see section 4.3.2.

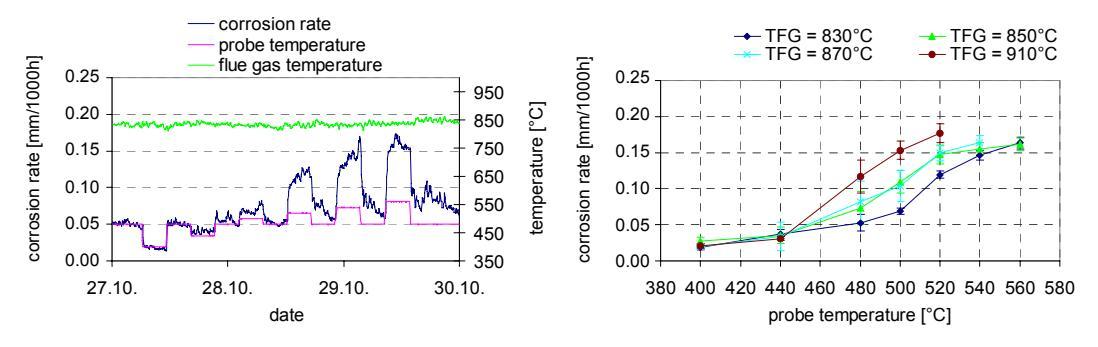
Figure 11: Corrosion signal of the corrosion probe at position M1 in dependence on the probe temperature and the flue gas temperature

Explanations: TFG ... temperature of the flue gas

right figure: mean values of corrosion rates for certain flue gas temperatures (+/- 10°C) and corrosion probe temperatures (+/- 1°C); error bars show the standard deviations

Furthermore, it can be seen that increasing corrosion probe temperatures result in increasing corrosion rates too. To illustrate this correlation, corrosion rates are shown during variations of the corrosion probe temperature in Figure 11.

Figure 11 - right shows data gained during the whole corrosion test run in dependence of the corrosion probe temperature for certain flue gas temperatures.

In Figure 11 it can be seen that the slope of the corrosion rates increases with probe temperatures between 400°C and about 520°C. When exceeding 520°C the slope decreases with increasing probe temperatures. This behaviour is not consistent with results found in waste incineration plants, in which cases the relation between the corrosion rate and the corrosion probe temperature was described via an Arrhenius function [8, 9]. This function indicates exponentially increasing corrosion rates with rising probe temperatures. Moreover, a relation between corrosion rates and probe temperatures following an exponential function has been found by Gruber [19], during corrosion test runs in a pilot-scale combustion plant using similar fuels as in the case at hand. The Arrhenius-correlation is based on the assumption, that the dissolution of the metal into the corrosion layer is the rate-determining step, which is a thermally activated process.

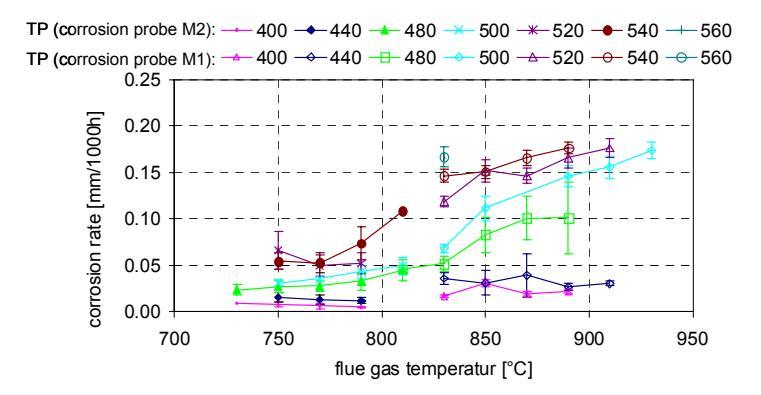
Figure 12: Comparison of corrosion rates of corrosion probe M1 and M2 in dependence of the flue gas temperature for certain probe temperatures <u>Explanations:</u> TP ... temperature of corrosion probe, error bars show the standard deviations

A comparison of the corrosion rates of the corrosion probes at the positions M1 and M2 show that the data can be combined quite well (Figure 12). It has to be noted that for this comparison only data gained after the plant shutdown has been used. Since before the shutdown no variations of the corrosion probe temperature have been performed in case of corrosion probe M1, only this reduced period could be used. For a probe temperature of 480°C, which was the reference temperature and is therefore the temperature for which most data is available, the corrosion rates merge almost without deviation. The data below a flue gas temperature of 810°C originates from corrosion probe M1.

Mean flue gas velocities at the positions of the corrosion probes during the period of the data shown in Figure 12 were 4.7 m/s (standard deviation: 0.5 m/s) in case of position M1 and 8.3 m/s (standard deviation: 0.3 m/s) for position M2.

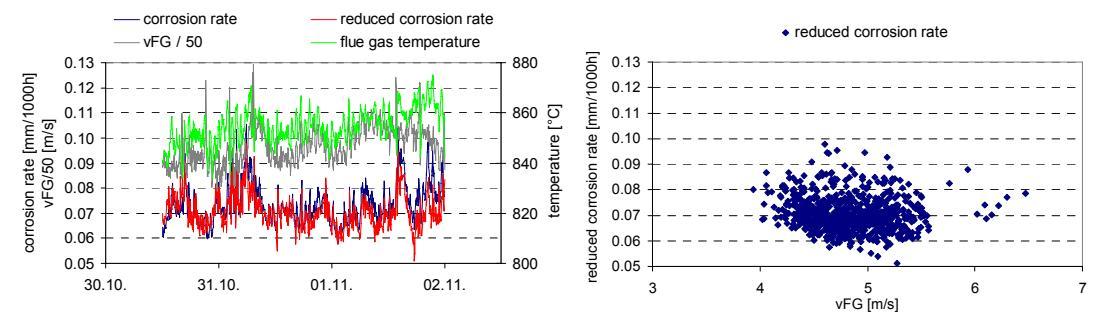
Figure 13: Corrosion rates at a constant probe temperature of 480°C as well as flue gas temperatures and flue gas velocities

Explanations: left figure: the flue gas velocities were divided by a factor of 50 to fit on the primary axis of the figure; right figure: reduced corrosion rates

Figure 13 - left shows the corrosion rates as well as flue gas temperatures and flue gas velocities (divided by 50 to fit on the primary axis) for corrosion probe M1. In Figure 13-right the reduced corrosion rates are plotted against the flue gas velocities.

From Figure 13 it can be seen that no clear correlation between the corrosion rate and the flue gas velocity can be identified. The results are not in line with the results from Gruber [19] and Maisch [9]. A similar result was found for the data of corrosion probe M2. Besides the attempt to find an influence of the flue gas velocity on the corrosion rate by calculating a reduced corrosion rate, Figure 12 already indicated that there is no such influence in the case at hand since the flue gas velocities were on different levels at position M1 (mean: 4.7 m/s) and M2 (mean: 8.3 m/s) and yet the corrosion rates merge quite well.

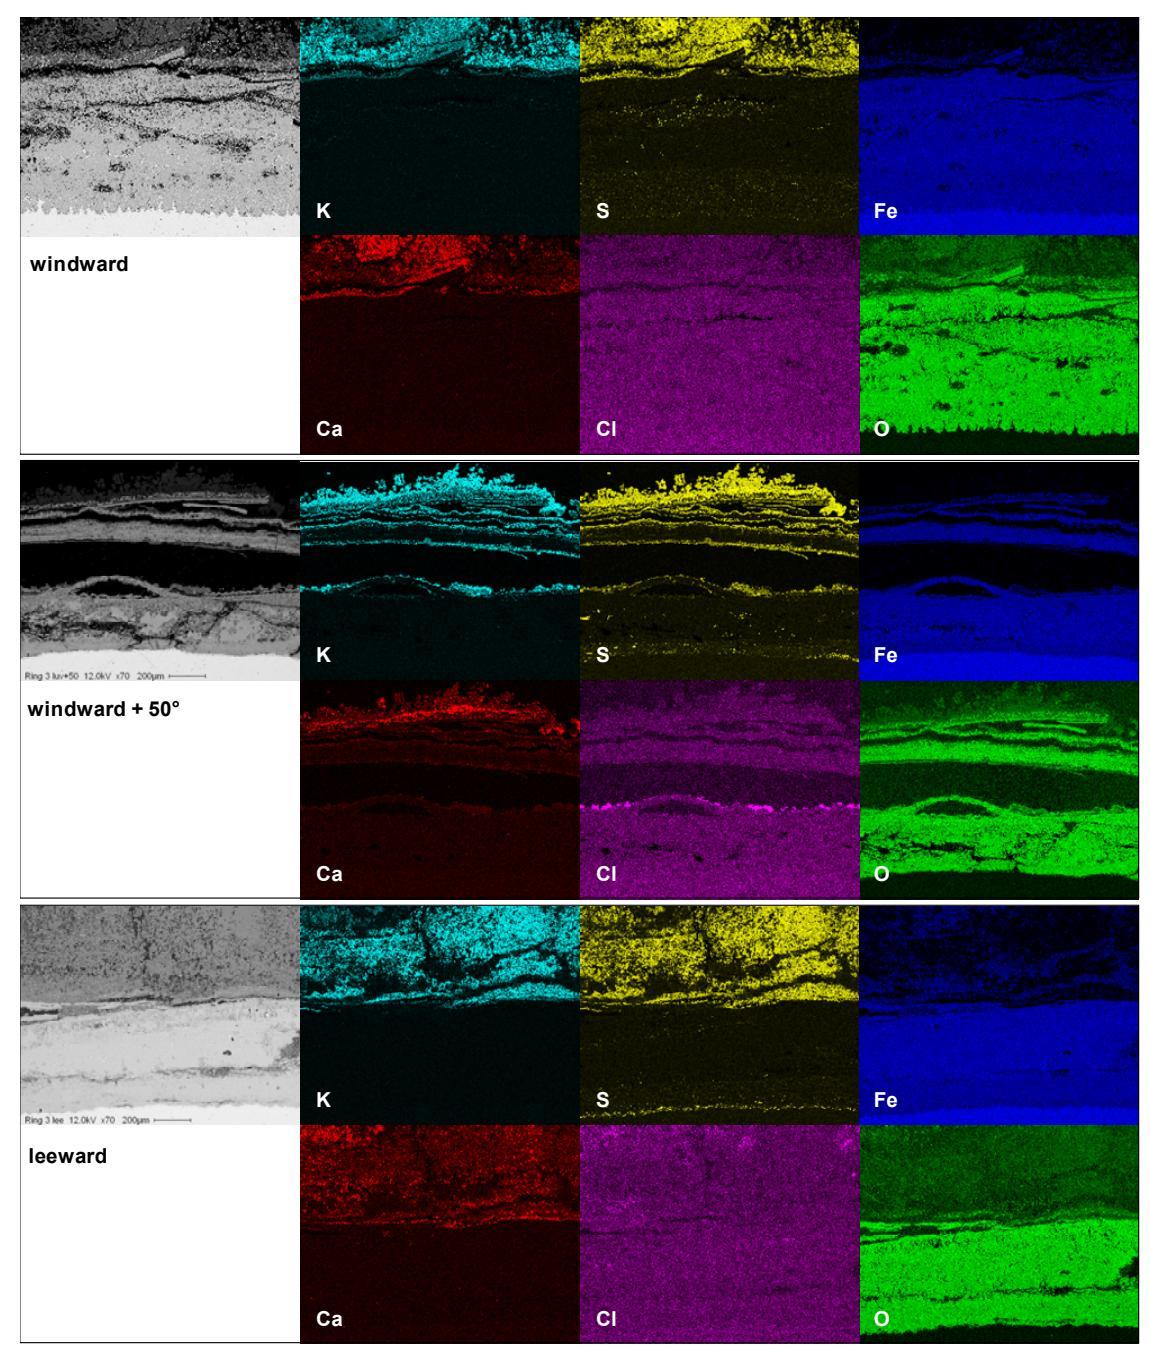
Figure 14: EDX-mappings of one ring from the corrosion probe at position M1

Generally, the deposits consist of Ca, K, S and O (Figure 14) indicating the deposits to be K- and Ca-sulphates and -oxides. This result is in good agreement with the results from the analyses of the deposit probe samples. S is also found in inner layers of the corrosion product and since K was also found in these areas, a layer-like formation consisting of corrosion product and deposits can be assumed. This could be caused by spallation of the corrosion product caused by the plant shutdown that happened during the test run and by the variations of the surface temperature of the probe.

Cl was only detected in small amounts in the inner deposit layers in some analyses (e.g. Figure 14 at windward+50°C) but no Cl was detected at the corrosion front in any analyses performed. Instead of Cl, an enrichment of S was found at the interface steel - corrosion layer. The general compositions of the deposits and the corrosion layer are the same for both corrosion probes including the S-enrichment on the corrosion front.
